CITY OF EUREKA

RE: PRETREATMENT INSPECTION REPORT

INSPECTION REPORT

Inspection Date:	9/20/2019	Announced Yes/No	Yes
Time:		Entry: 9:00 am	Exit: 12:05 pm
Facility Name:	Pacific Seafood Eureka	Address:	1 Commercial Street Eureka, CA 95501
Permit #:	37	Classification:	Significant Industrial User
Facility Contacts:	David Bodiroga	Title:	Maintenance Manager
	Rick Harris	Title:	General Manager
Inspector:	David Adams	Signature:	<i>D. Adams</i>
		Date:	10-29-19
Deputy Director of Public Works Utility Operations:	Michael Hansen	Signature:	<i>Michael Hansen</i>
		Date:	10-29-19

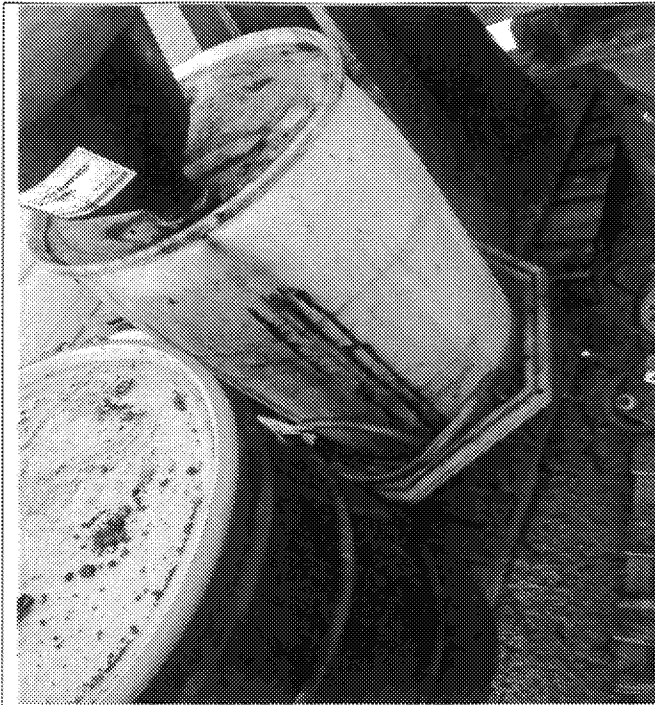
Photograph 1: Waste oil drum

1. A drum of waste oil was observed in the outdoor chemical storage shed with no labelling of its contents and no hazardous waste label (Photograph 1). This shed has no floor and is positioned so that flow of any spilled material may reach the adjacent storm drain inlet. The drum is positioned inside a tray that acts as secondary containment, however, this tray is limited in size. It is unclear how full this drum gets before being disposed of by a waste hauler. Used batteries were observed with no secondary containment. A container of unknown substance was also observed in this area with no labelling. David Bodioga opened it and determined the substance to be absorbent material to be used in case of spills.

Part 2 (D) of the facility's permit states: "The permittee shall remove or double-contain any hazardous materials, stored near drains, in a manner which will ensure that accidental spills or leaks will not enter the storm drain or sanitary sewer. A spill prevention kit shall be made available for employees to contain or prevent accidental discharges to the sanitary sewer. Employees shall be trained on the use of the spill prevention kit."

Part 2 (E) of the permit states: "Drums or other vessels used to collect and store hazardous materials shall be sealed, labelled, and stored in a protected manner."

Part 2 (F) of the permit states: "Drums or other vessels used to collect and store wastes shall be sealed, labelled, and stored in a protective area."

The permittee is required to clearly and properly label all hazardous waste or hazardous materials. The permittee is required to provide secondary containment adequate to ensure that a leak or spill will not enter the storm drain for the waste products stored in this area. It is recommended that the permittee label all containers to reflect the contents they contain for easy identification.

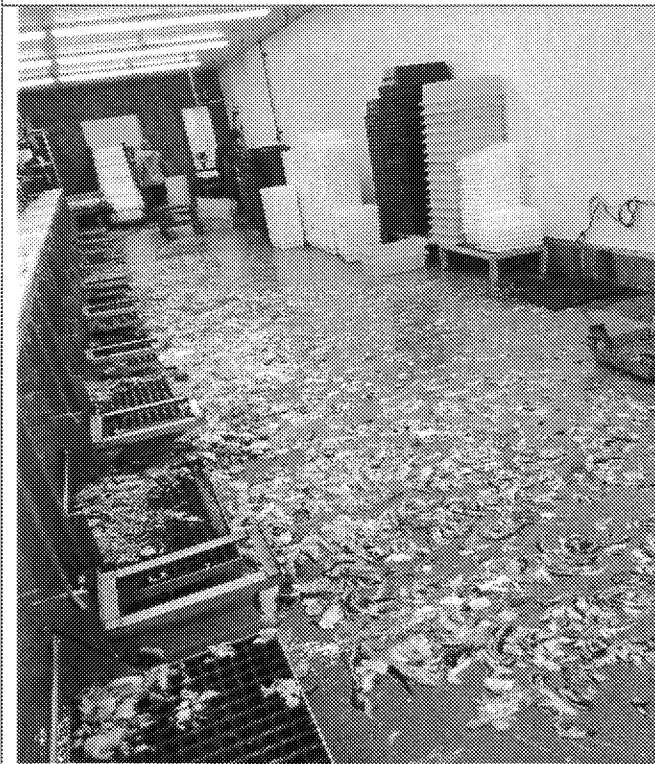
Photograph 3: Groundfish fillet room

3. A groundfish fillet processing shift had just ended and clean-up operations were underway when inspection of this area took place. The floor of the area was observed to be covered in fish processing waste and an employee was observed hosing the waste from one side of the room toward the other which contained the drain. The drain was equipped with screens and the majority of the waste had not reached the drain. Mr. Bodioga explained that the general practice is to clear the floor of waste with squeegees, then scoop to a conveyor for removal and later recycling by Eco-Nutrients, LLC.

It is recommended that the facility examine its fish processing waste clean-up procedures to ensure the drainage system and pretreatment system do not become overwhelmed with solid material.
